HAZARDOUS AND REGULATED MATERIALS PRE-RENOVATION ASSESSMENT REPORT

COMMERCIAL BUILDINGS

450 MacKenzie Avenue South Willaims Lake, BC

Report Date: November 25, 2024

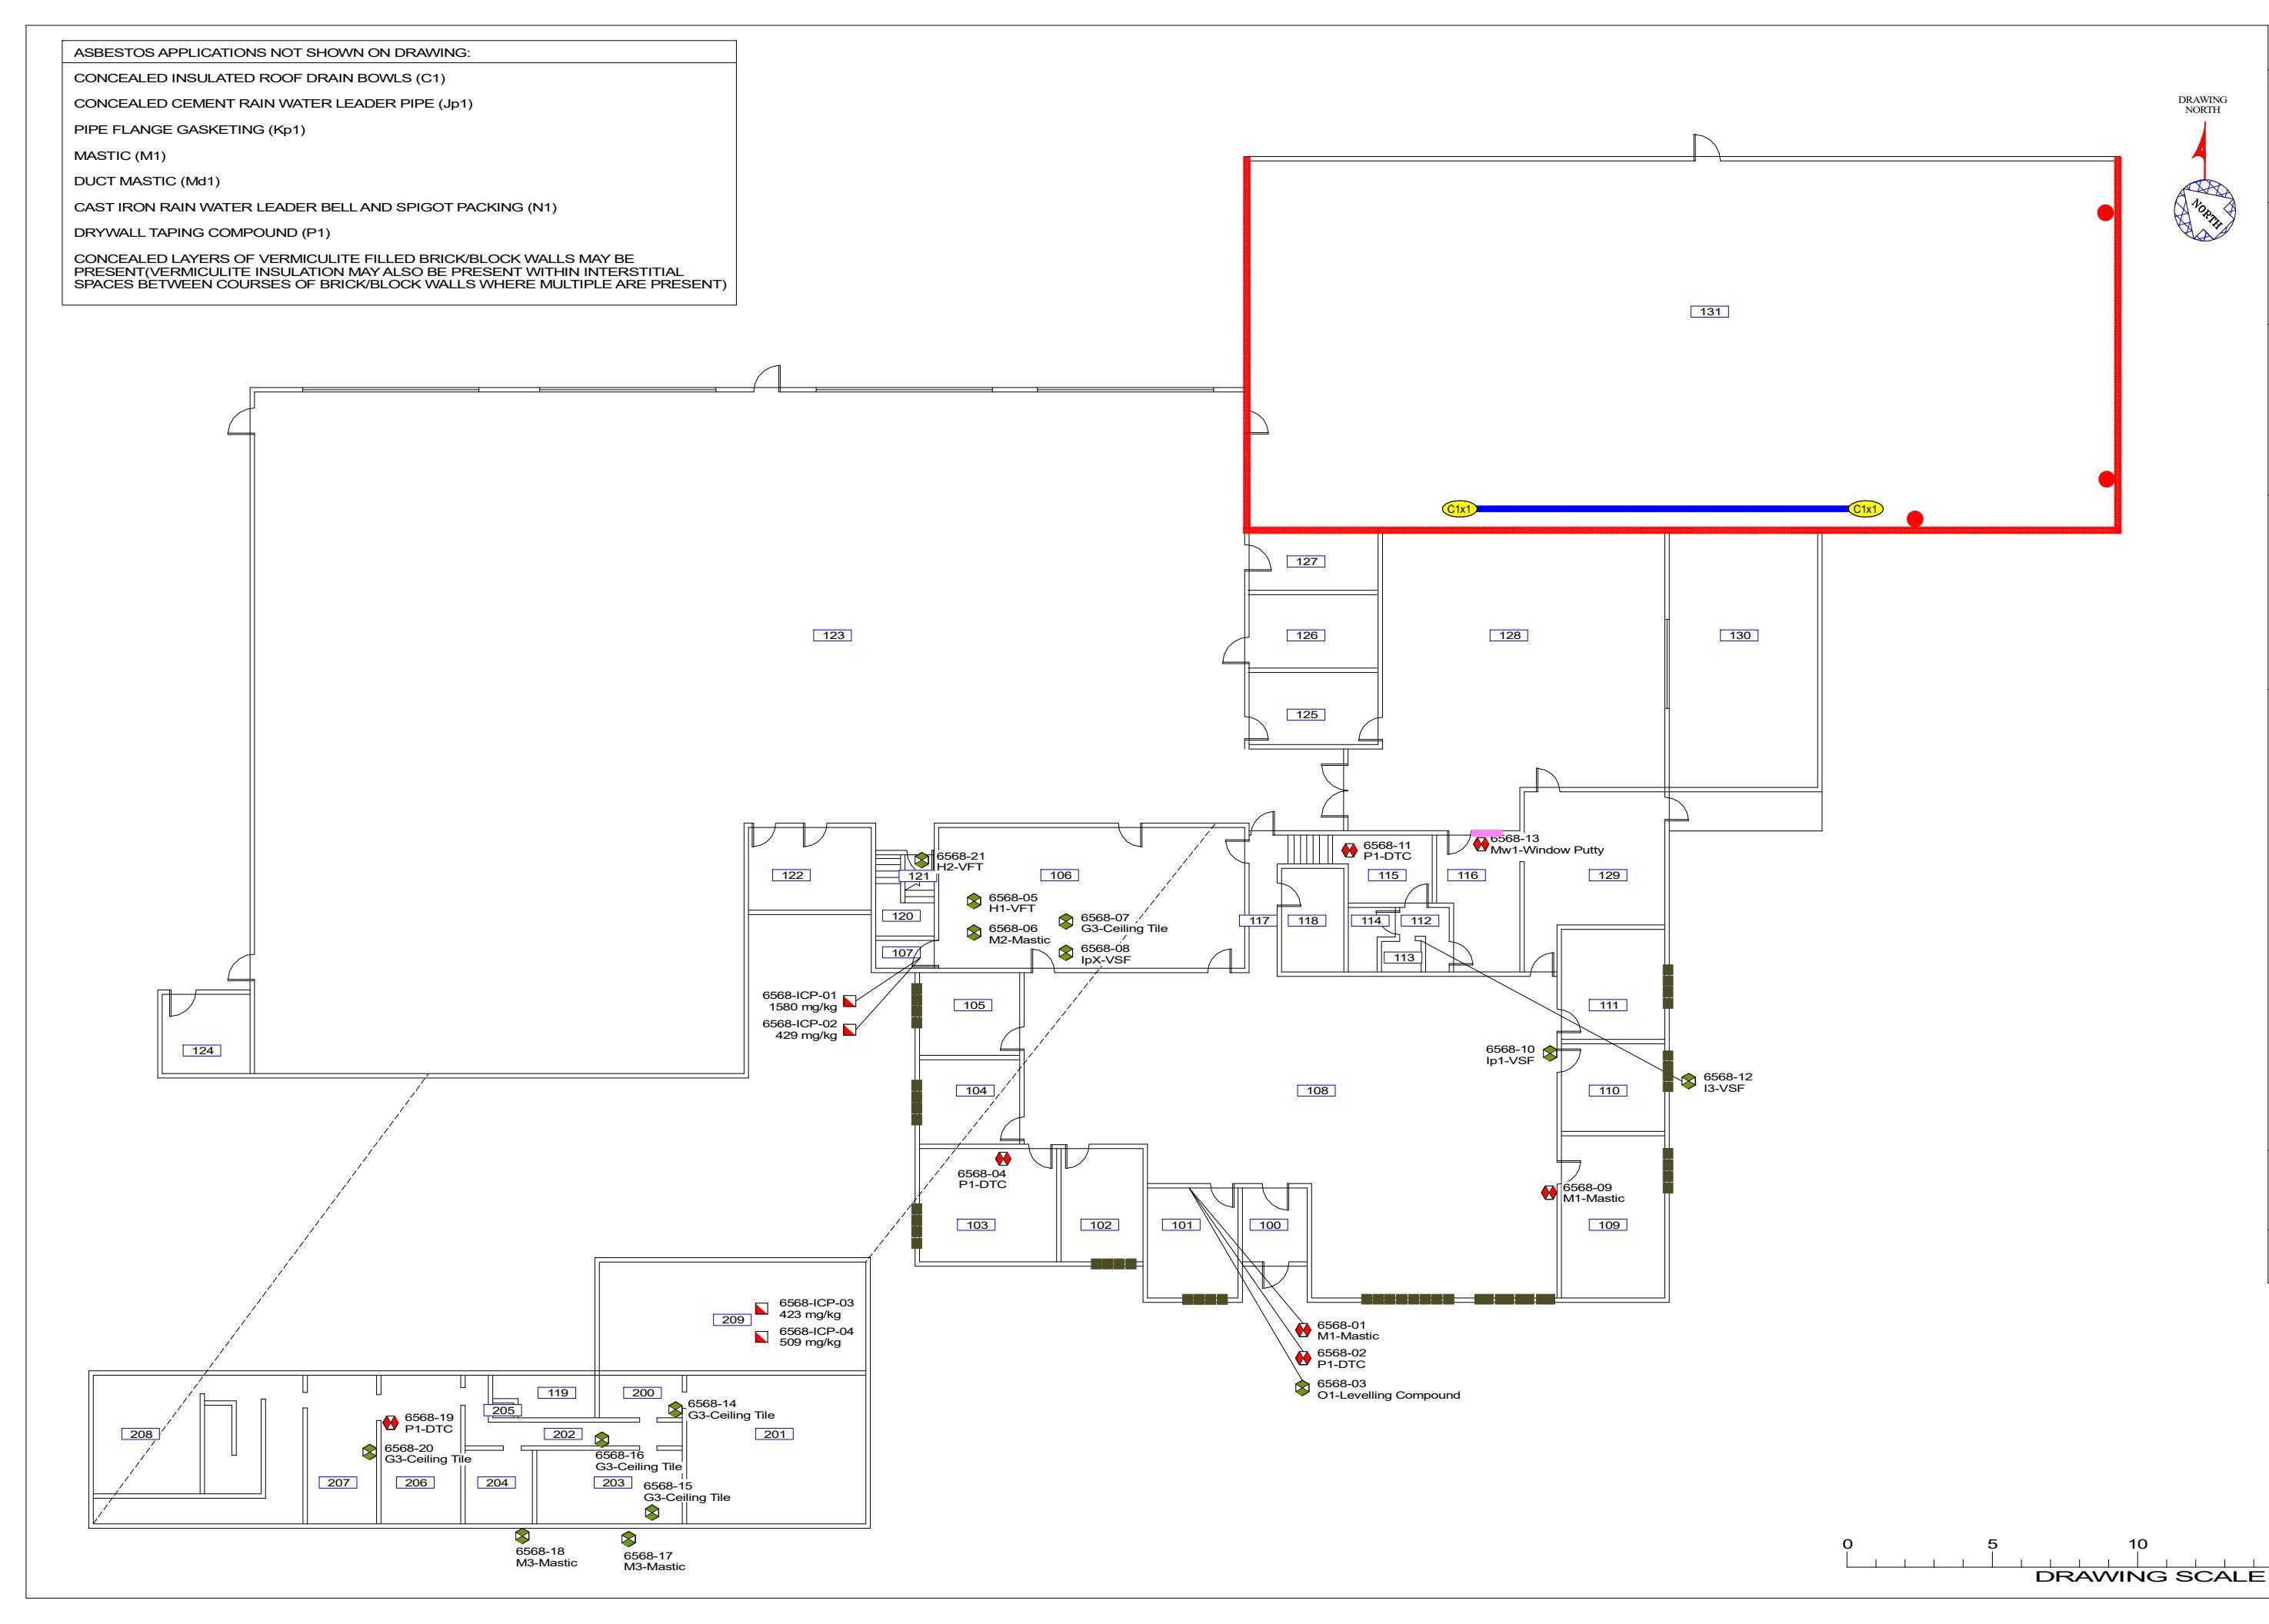
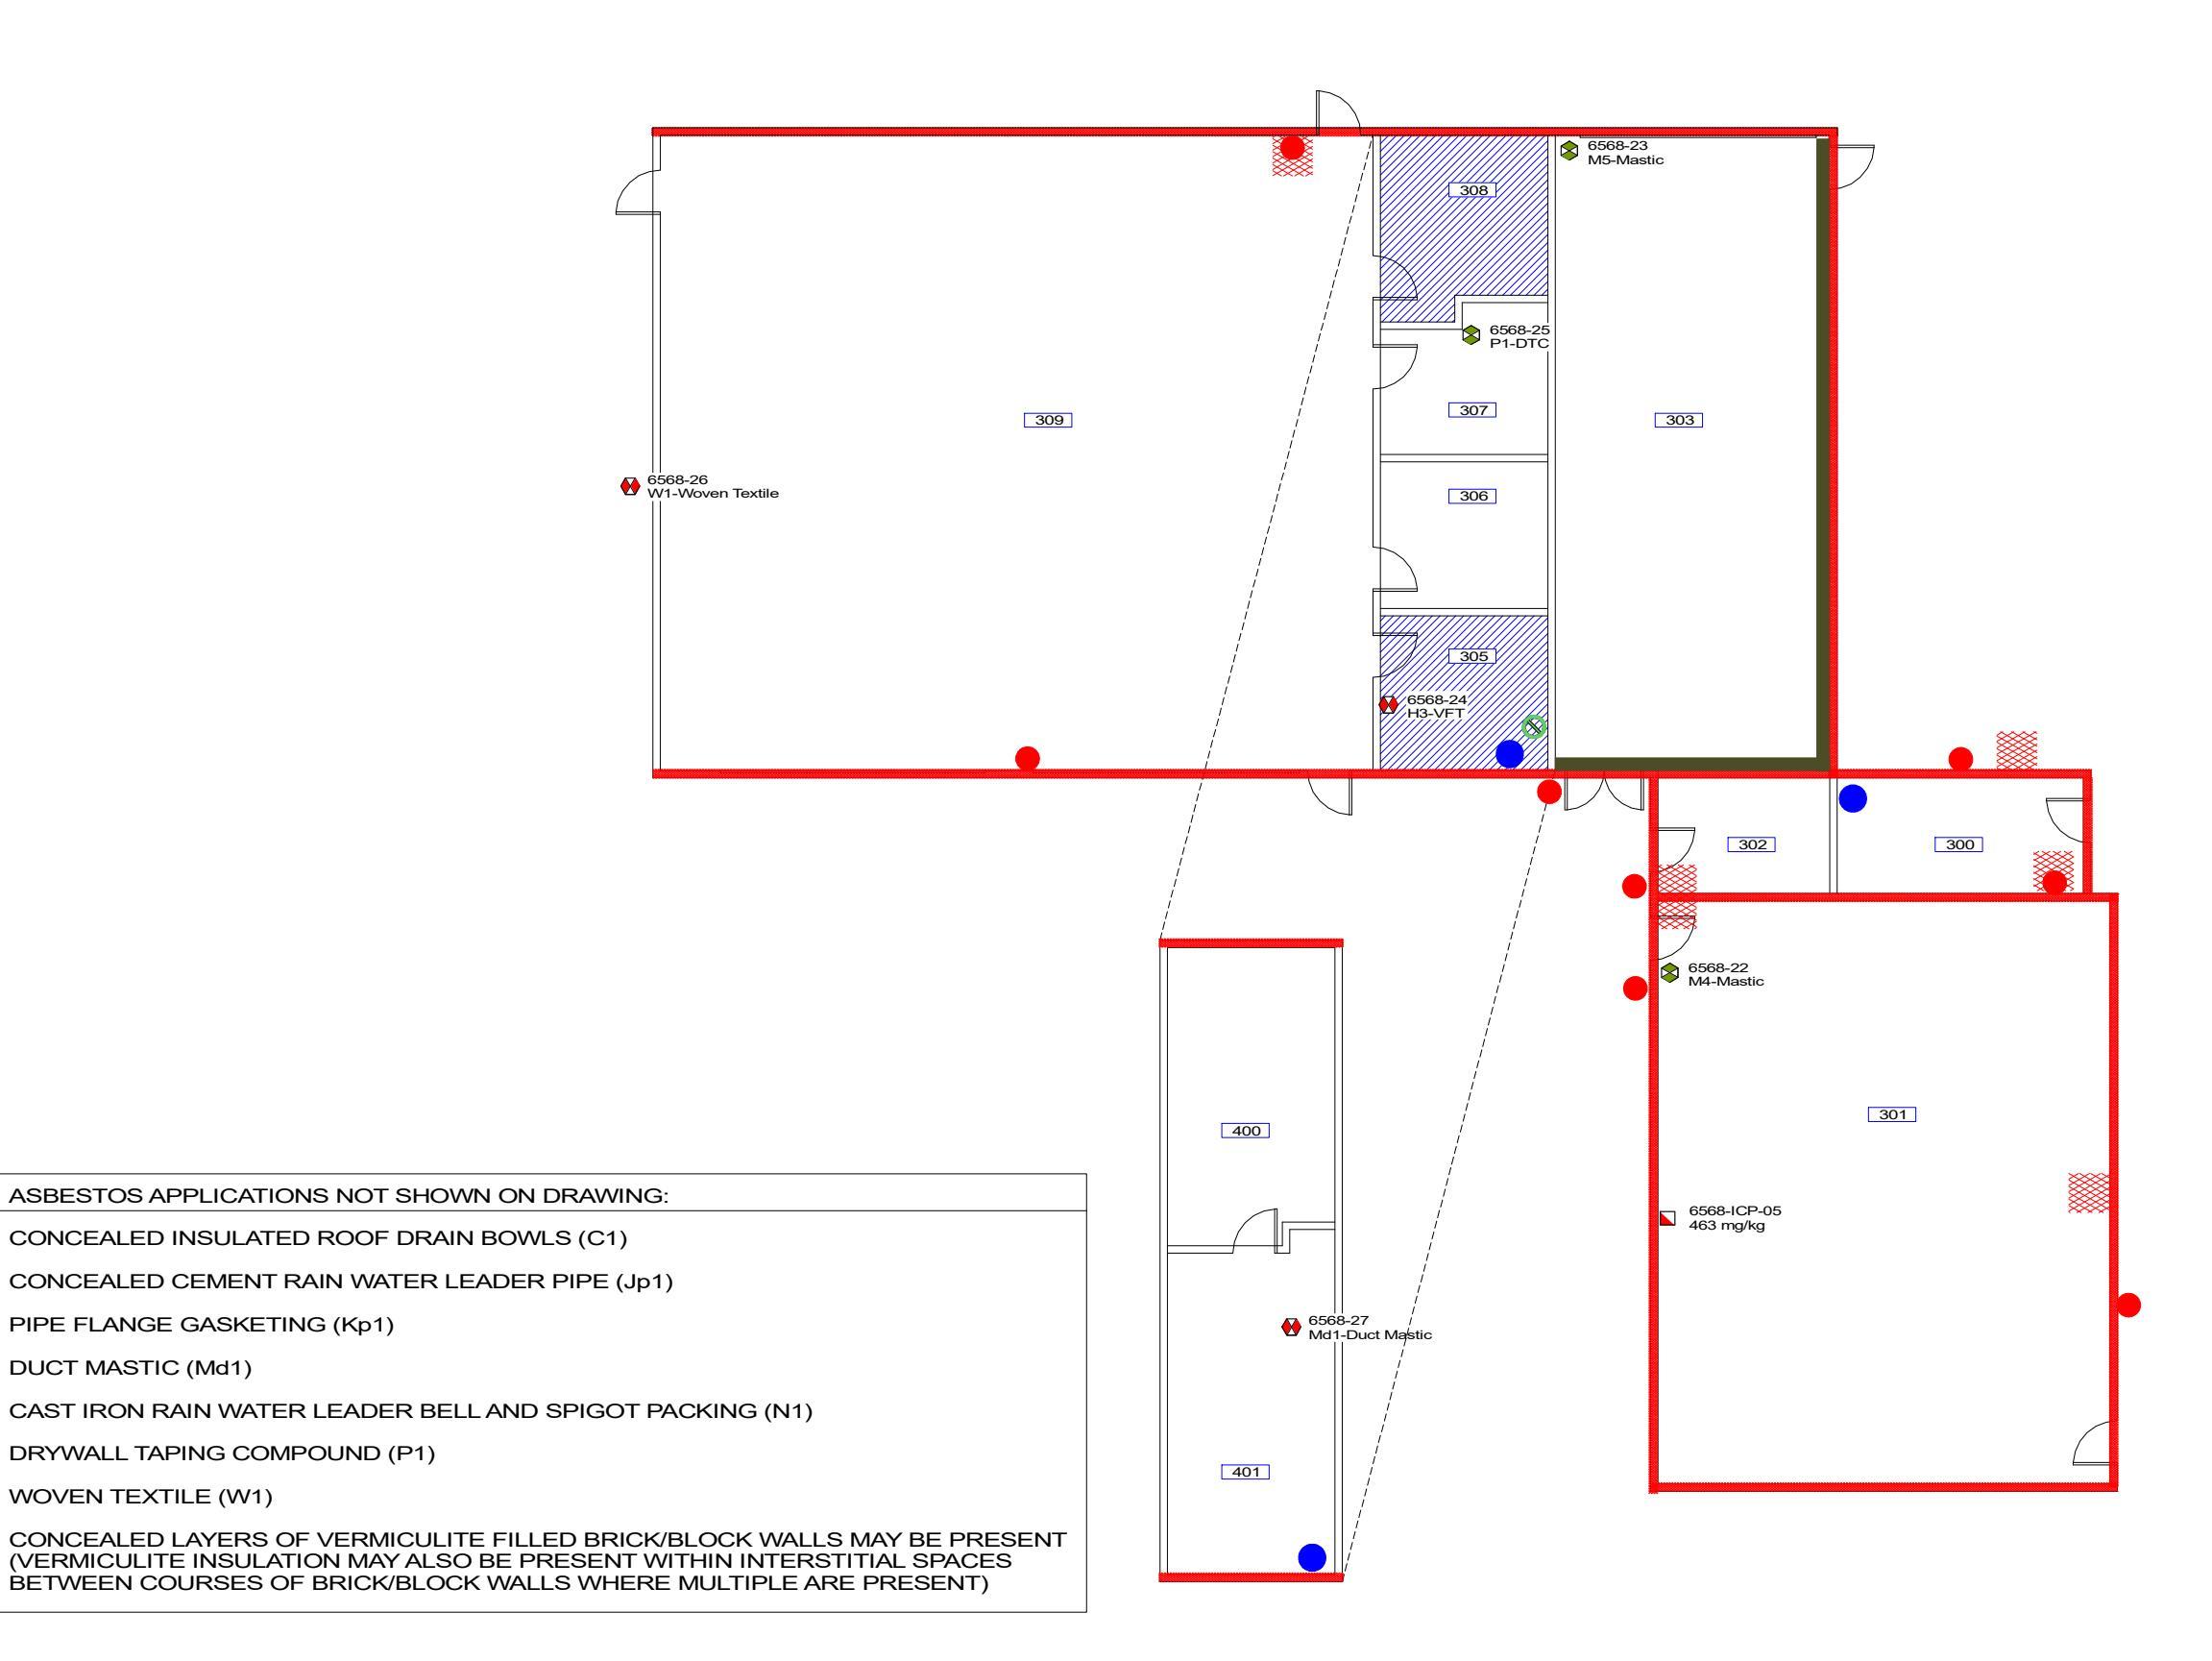
APPENDIX B Floor Plan

• Small areas of vermiculite debris found within the shops building. See Appendix B for known locations.
